DEPARTMENT OF TRANSPORTATION

Quality Assurance and Source Inspection

Contract #: 04-0120F4Cty: SF/ALA Rte: 80 PM: 13.2/13.9File #: 69.28**WELDING INSPECTION REPORT****Resident Engineer:** Pursell, Gary**Address:** 333 Burma Road**City:** Oakland, CA 94607**Report No:** WIR-010008**Date Inspected:** 30-Oct-2009**Project Name:** SAS Superstructure**OSM Arrival Time:** 1900**Prime Contractor:** American Bridge/Fluor Enterprises, a JV**OSM Departure Time:** 700**Contractor:** Zhenhua Port Machinery Company, Ltd (ZPMC), Changxing Island **Location:** Shanghai, China**CWI Name:** Wang Chung Ging, Li Jia**CWI Present:** Yes No**Inspected CWI report:** Yes No N/A**Rod Oven in Use:** Yes No N/A**Electrode to specification:** Yes No N/A**Weld Procedures Followed:** Yes No N/A**Qualified Welders:** Yes No N/A**Verified Joint Fit-up:** Yes No N/A**Approved Drawings:** Yes No N/A**Approved WPS:** Yes No N/A**Delayed / Cancelled:** Yes No N/A**Bridge No:** 34-0006**Component:** Tower/OBG**Summary of Items Observed:**

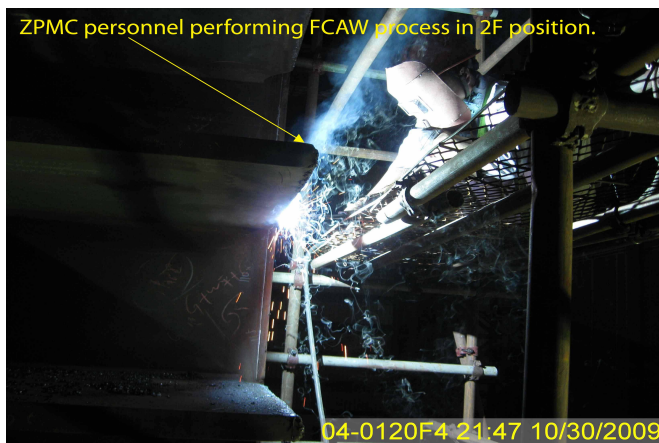
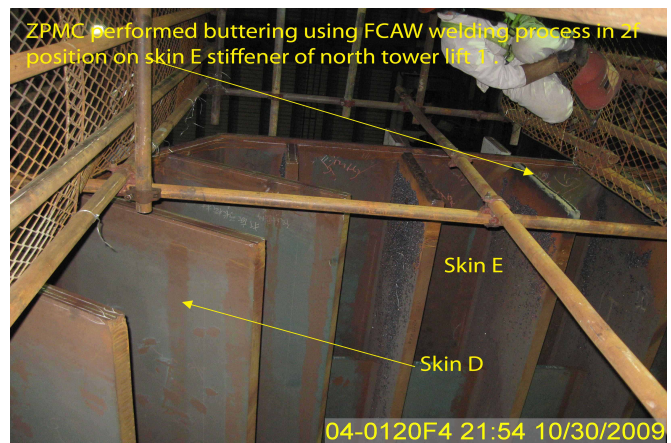
This Caltrans Quality Assurance (QA) Inspector observed ZPMC personnel performing buttering welds at the end of the third stiffener on skin E from skin D on north tower lift #1 using the Flux Cored Arc Welding (FCAW) process. ZPMC personnel performed this 2F position welding using the welding parameters based on the 3F position weld procedure. The 3F (WPS-345-FCAW-3G (3F)-Repair) welding parameters are not acceptable for welding in the 2F position (WPS-345-FCAW-2G (2F)-Repair). For additional information see attached photos. Incident report was issued.
